Underwater Photo-Optical Instrumentation Applications

Volume 24

THE SEA CHANGE -- 300 FATHOMS DEEP, 3 YEARS LATER

James F. Selvidio
NAVAL UNDERWATER SYSTEMS CENTER
New London Laboratory
New London, Connecticut 06320

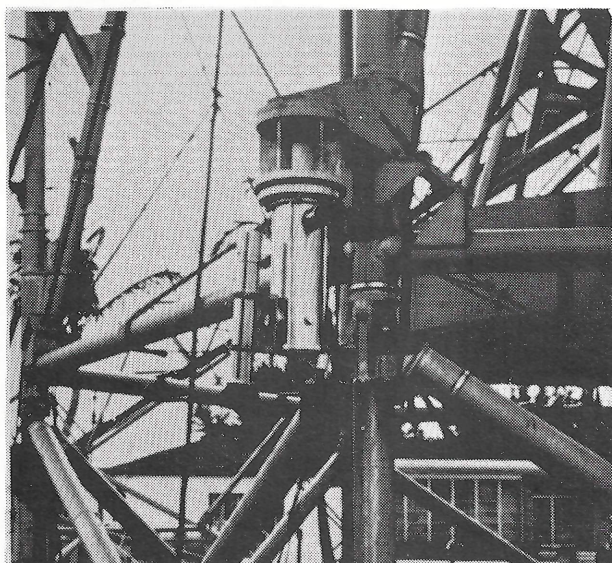
Fig. 3. Camera Pan and Tilt Unit

The pan and tilt unit was a model RPS-3. This unit worked a little "jumpy" on the emplantment, which we previously attributed to the possibility that a cable might have twisted during descent and was resting on the outer housing, causing the unit to bind slightly. During the reactivation it again started off a little stiff, but after a few minutes this condition cleared up. I believe this latter case was due to the accumulation of fine sand particles between the revolving part of the pan unit (operating in azimuth) and the unit's base.

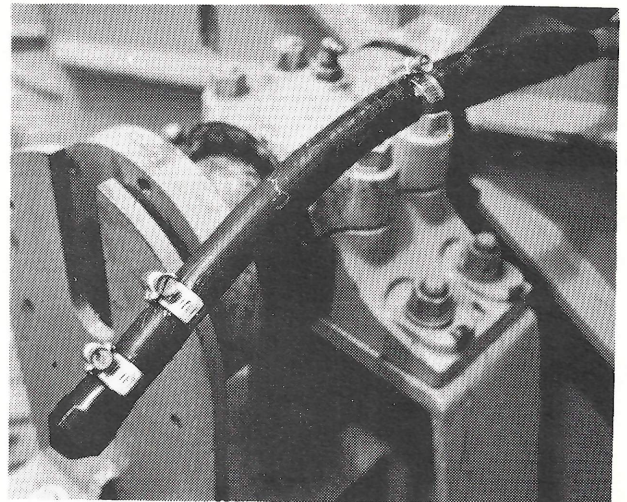
Fig. 10. Video Cable End Sealed

Wrapup operations required that the ship head toward shore to run off the remaining cable. The end of this cable was sealed by dipping it in neoprene cement and then taping (Fig. 10). A rubber hose, plugged at one end, was cemented, inserted over the cable, and secured in place with an aero-clamp. A grappling line was attached to the video cable for planned future recovery and subsequent video reconnect for visual inspection of the unit, when and if needed.

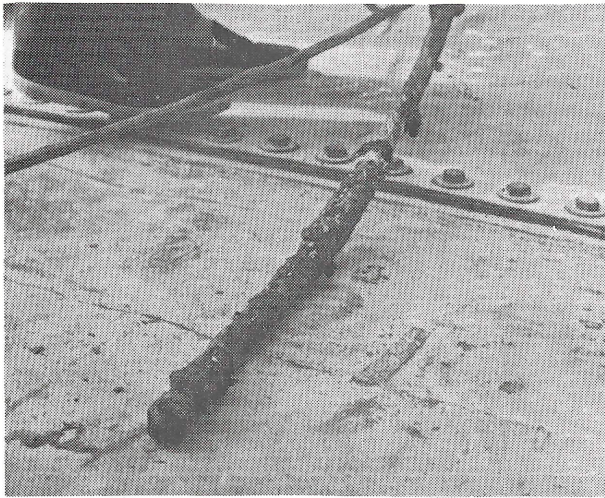
Fig. 17. Video Cable End Seal

With the end of the video cable on board and the cable stoppers attached, approximately 30 feet of cable was routed into the dry laboratory space and secured to a suitable work area (Fig. 17). Here the video cable end seal was removed and the conductors were prepared for application of spade lug connectors and a VHF coaxial connector.
