Underwater Photo-Optical Instrumentation Applications

Volume 24

THE SEA CHANGE -- 300 FATHOMS DEEP, 3 YEARS LATER

James F. Selvidio
NAVAL UNDERWATER SYSTEMS CENTER
New London Laboratory
New London, Connecticut 06320

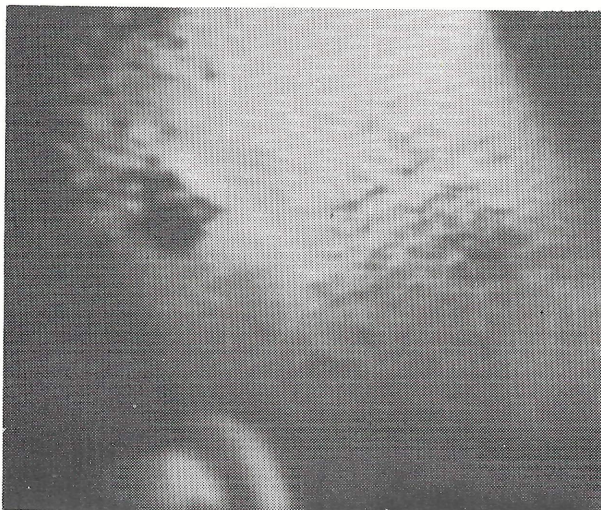
Fig. 9. Ocean Bottom View

As the cage approached the ocean floor, a view of the bottom came on the monitor screen (Fig. 9). Moments later, bottom contact!

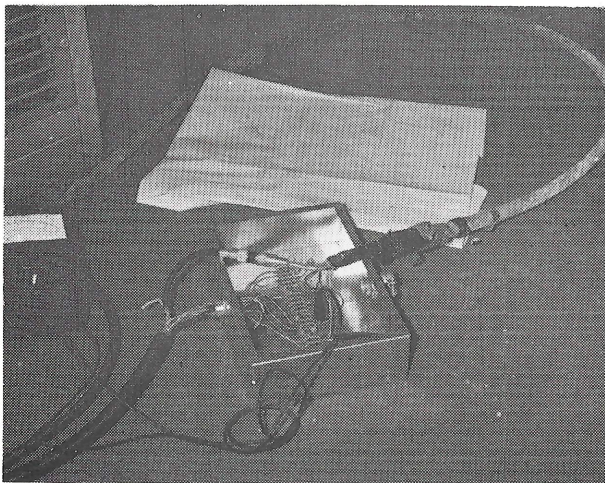
Fig. 18. Junction Box

The sea cable was checked for continuity and connected to a junction box (Fig. 18), which had been prewired and assembled at the Laboratory, with Jones-type terminal boards and pigtail connectors.

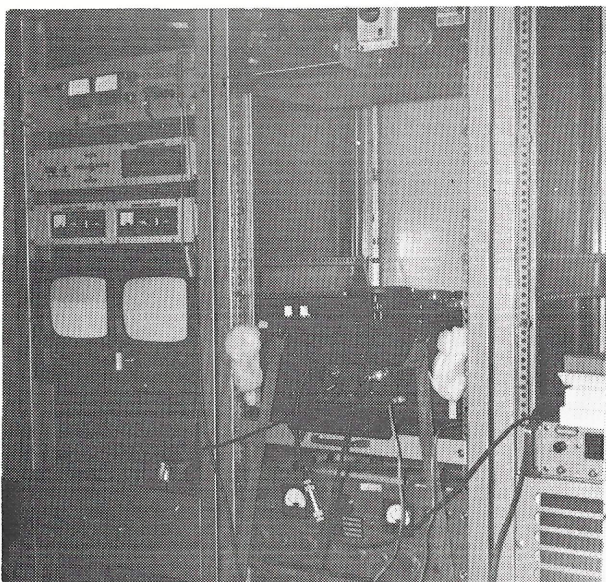
Fig. 19. Equipment Rack

Connections were then made to the camera, the pan and tilt unit, and the lights. Power supplies and monitoring equipment were mounted into the equipment rack (Fig. 19). As power was applied to the light source, it was monitored. The results indicated that the lamp was functioning properly. Power was then applied to the camera, and indications were also favorable. No video was present on the monitor at this time, because of the characteristics of the mercury vapor lamp (i.e., ionization of mercury vapor, which usually takes 5 to 7 minutes to come up to full light output). When the lamp did come up to its full operating condition, the scroll of the unit came into view.
